To: Refuge Manager, Arapaho National Wildlife Refuge, Walden, Colorado

From: Refuge Hydrologist, Division of Water Resources, Region 6

Subject: Field Inspection of Mainstem Diversion Flumes

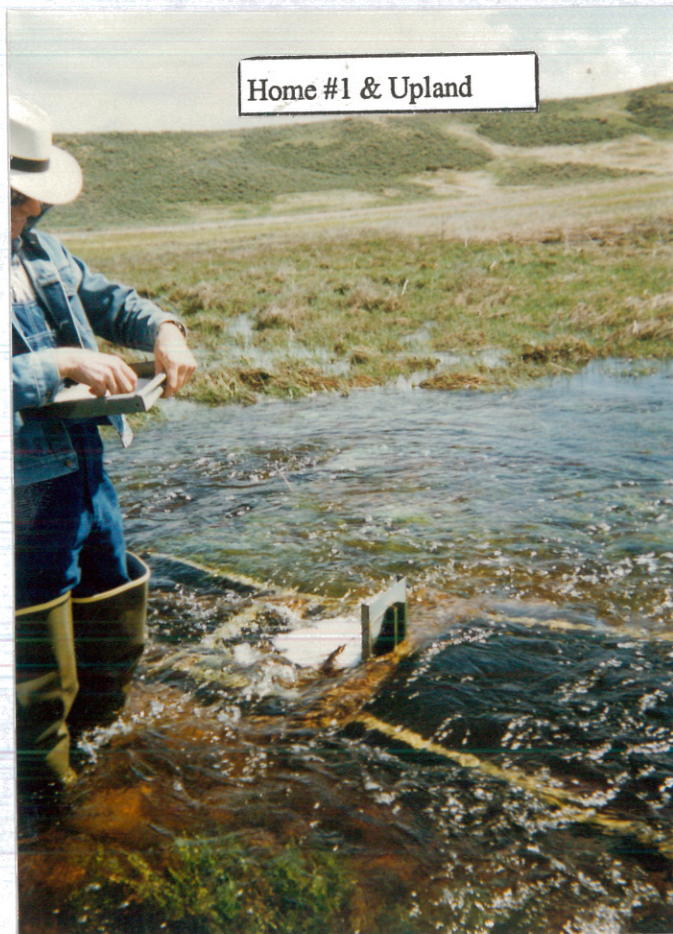
Hill & Crouter

ditch not clean, submerged

staff gage on bank, not level,  
very submerged, willow  
problem

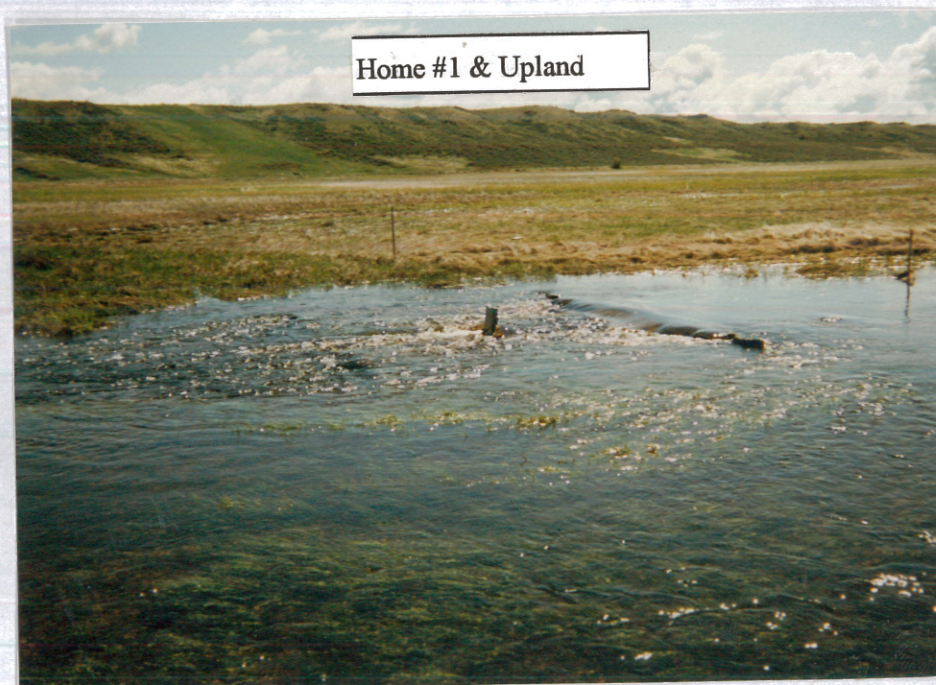
Home #1 & Upland

not level

looks lower on upstream end

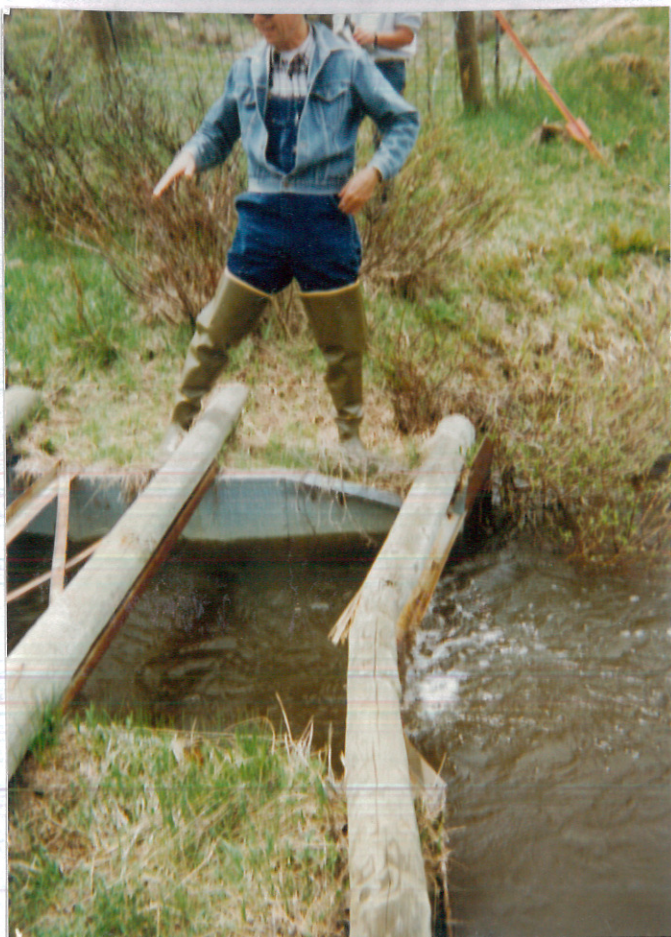
North Park #6

4 ft  
no staff gage

water marks indicate  
flume working properly

is working  
measured = 5.3 cfs  
predicted = 5.06 cfs

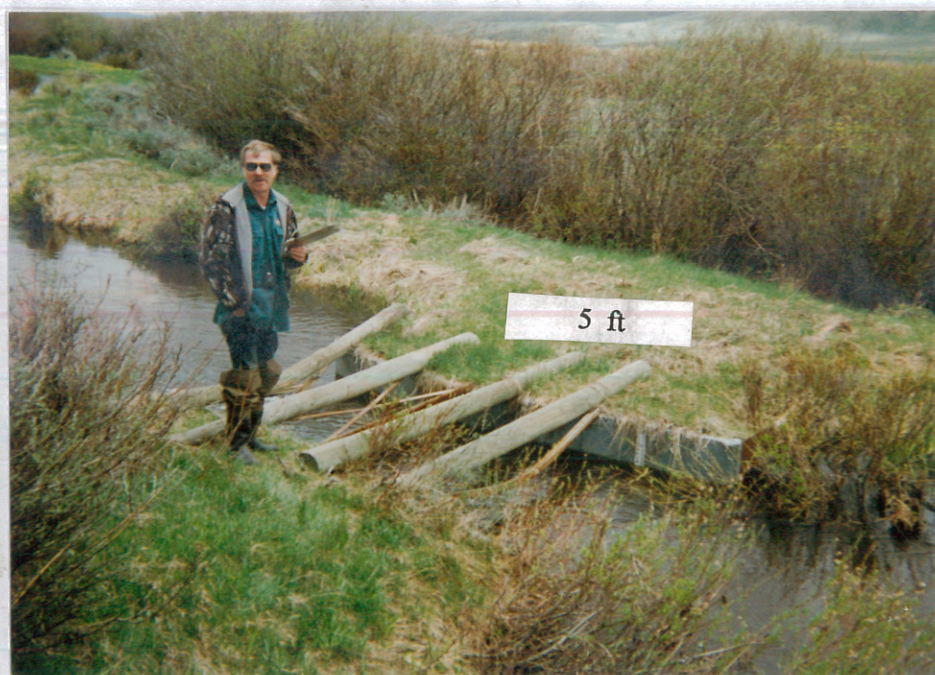
Oklahoma #1

flume not level

set too low, raise 4" to 6",  
consider moving downstream  
below the large leak of  
wastewater from the Midland  
ditch  
measured flow = 25 cfs  
predicted flow = 40 cfs

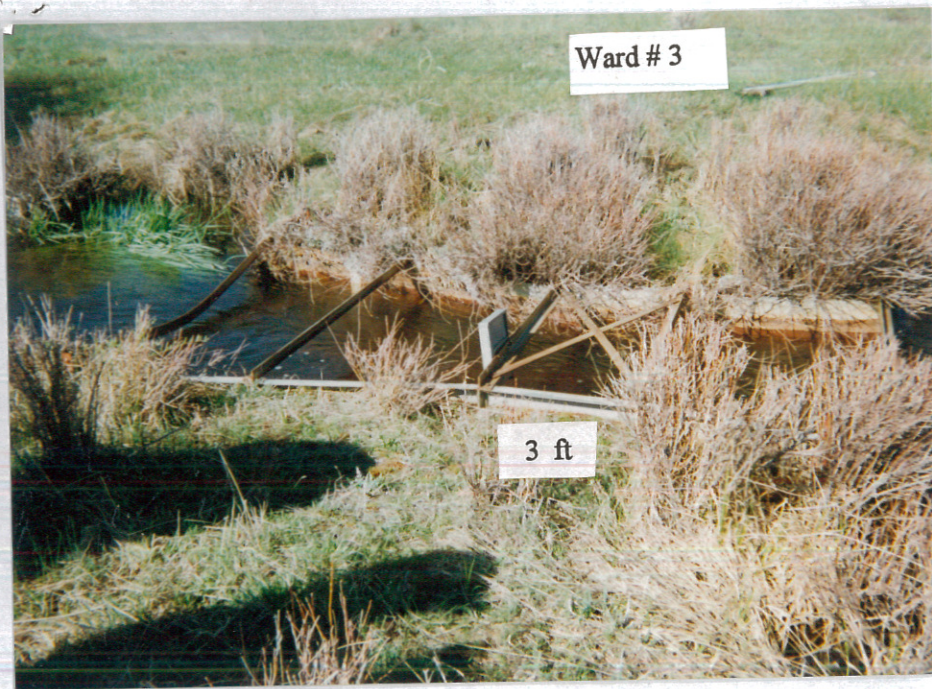
square wooden headgate

submergence created by  
grasses in channel, needs to  
be raised 4".

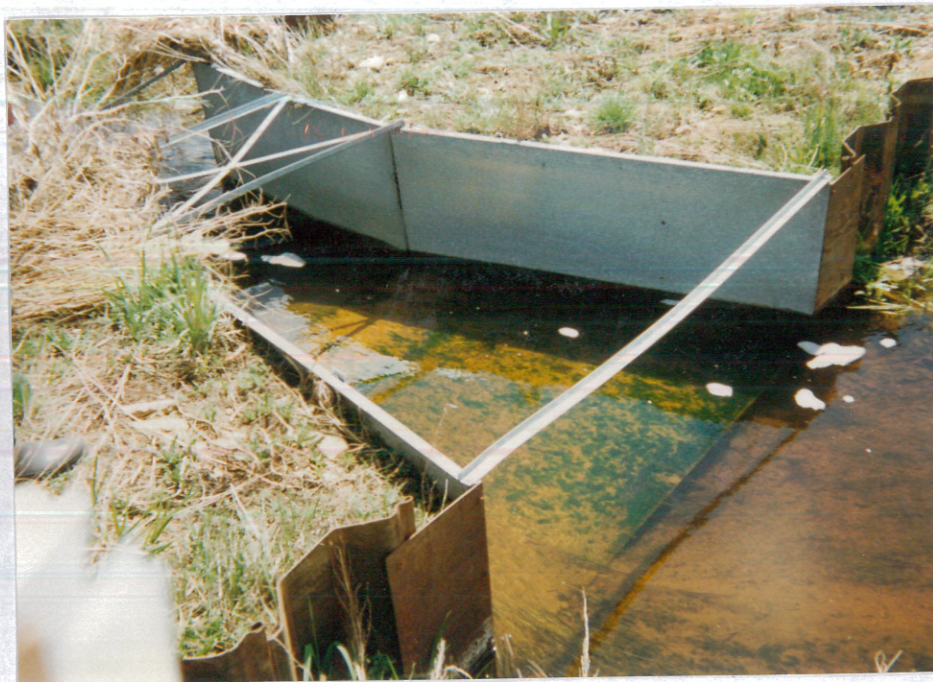
Riddle Ditch

not level & not aligned

set too low, raise 4 - 6",  
measured = 5.4 cfs  
predicted = 9 cfs
